**Stress Corrosion Study of
Carburized AISI 9310 and
Carburized M-50 NiL Steels**

National Aeronautics and
Space Administration

TECHNICAL PAPER

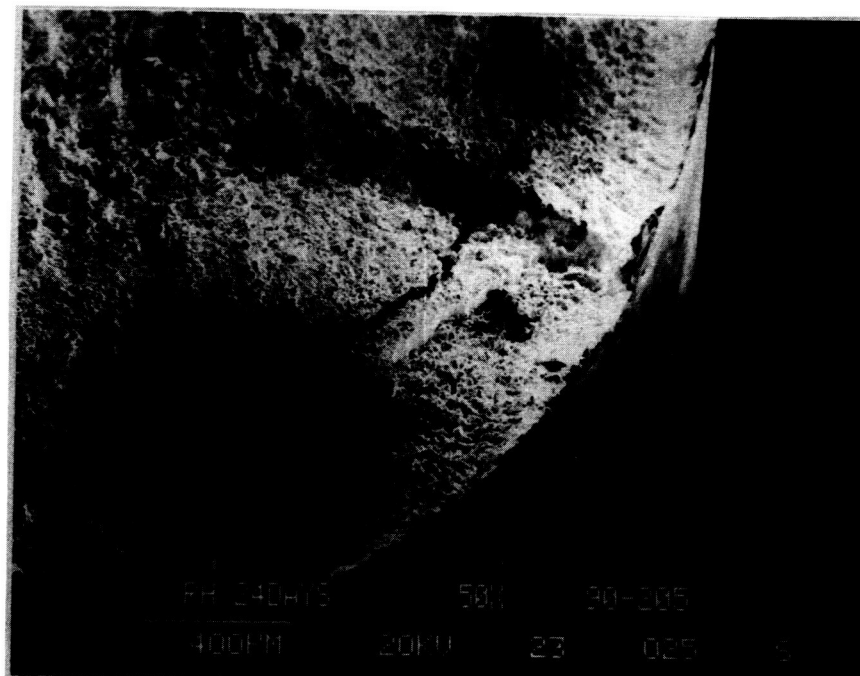
Figure 24A. SEM Views Showing Cracking of the Fractured Surface of a Carburized AISI 9310 Steel Specimen Stressed to 345 MPa (50 ksi) and Exposed to 24 Days of Humidity.

Each carburized AISI 9310 specimen (bare and TDC plated) that failed in the SCC test showed a circumferential crack between the case and the core. This is illustrated in Figures 16 and 19 to 24B. The difference in hardness between the case and the core on stressed specimens exposed to a highly humid environment over a period of time might have been a contributing factor for those cracks since no cracks were seen on the samples pulled in a tensile test (Fig. 25). Some of these fractures show stress corrosion features (Figs. 23B and 24B).
